Araştırma Makalesi / Research Article

**Kültürel Miras Alan Yönetimi ve Yönetim Planı: İshak Paşa Sarayı
Örneği***Cultural Heritage Site Management and Management Plan: The Case of İshak
Pasha Palace*Şehnaz ERASLAN¹

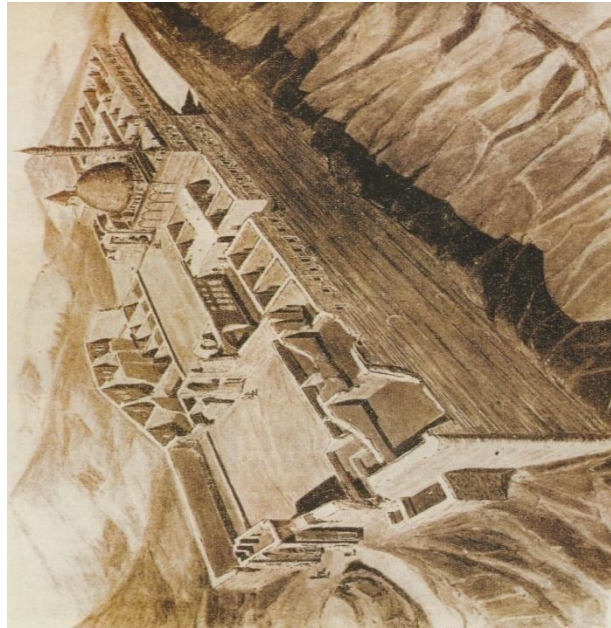
The first official and systematic studies on Ishak Pasha Palace were initiated during the Republican period under the leadership of the Ministry of Culture. In this context, in 1956, the General Directorate of Antiquities and Museums appointed the archaeologist Mahmut Akok to conduct detailed architectural surveys. His comprehensive measured survey represented the first scientific documentation of the palace and established a solid foundation for future conservation studies (Akok, 1961) (Fig.2)

Fig.2. Ishak Pasha Palace measured survey by Akok (Akok, 1961: lev.XXXI)

The documentation and analytical surveys led by Akok marked an essential step toward understanding the architectural configuration and spatial integrity of the monument. These efforts provided valuable baseline data for the conservation of its original plan and structural layout (fig.3)

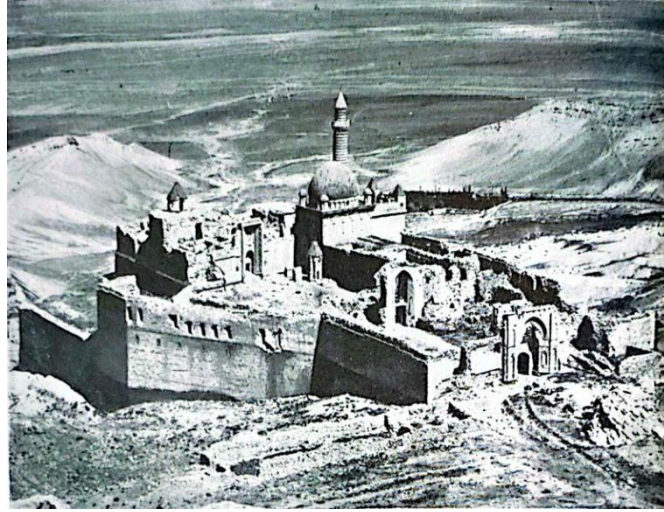
Fig.3. General view of Ishak Pasha Palace in the 1960 (Akok,1961: lev.XX, fig.1)

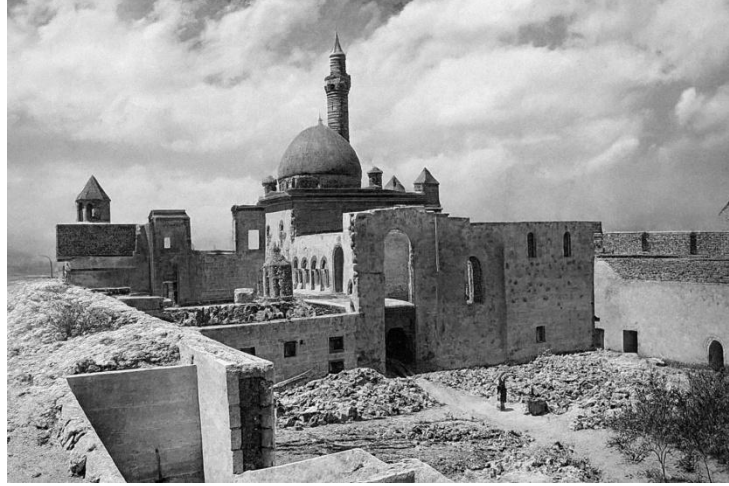
Fig.4. General view of Ishak Pasha Palace during the early days of restoration and excavation works, 1994. (Gündoğdu,1996:131,fig.2).

In this context, a large-scale restoration project was launched under the Ministry's coordination in 1992. The initiative represented the first comprehensive conservation campaign for Ishak Pasha Palace undertaken in accordance with modern preservation principles. The project, completed in 1994, was officially approved by the Erzurum Regional Council for Conservation of Cultural and Natural Properties. Simultaneously, between 1992 and 1995, archaeological excavations directed by Hamza Gündoğdu were carried out to complement the architectural restoration Works (Fig.4).

Among the major interventions of this period was the removal of previously used concrete mortar in certain wall sections and its replacement with lime mortar compatible with the original stone texture. Masonry walls outside the harem section were repaired, while collapsed portions were reconstructed using surviving material traces and archival documentation. In 1995, the dungeon area was cleared, and test excavations in the forecourt revealed the remains of terracotta water conduits supplying the palace. In the *selamlık*, original stone pavements were uncovered, and deteriorated wall and floor surfaces in the courtroom were renewed. Two-storey chambers located on the southern side of the second courtyard were excavated and structurally supported with iron scaffolding due to severe cracking.

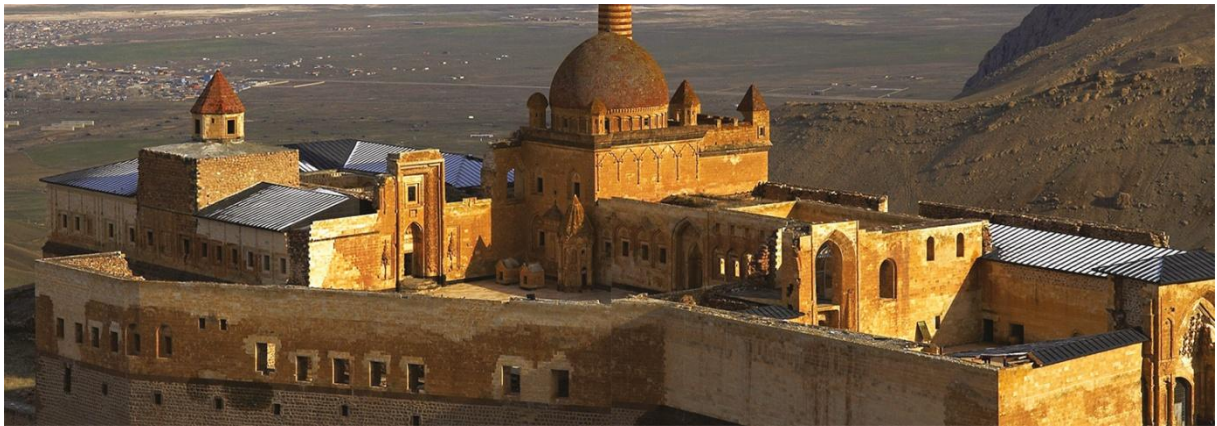
One of the main focuses of the project was the conservation of the harem cells. Except for the *Muayede Hall*, all openings were temporarily covered with pitched roofs to protect the interiors (Fig.5). Excavations conducted in the harem and courtyard areas uncovered the palace's historical water distribution system and terracotta pipelines (Gündoğdu, 1996; Belli, 2011). During 1997–1998, extensive restoration works were undertaken on the portal façade, tower staircases, and outer stone cladding, contributing significantly to the recovery of the palace's façade coherence.

Fig.5. Roofing practice in the 1990s, (CSB, 2025).

However, structural assessments conducted between 2004 and 2006 revealed significant technical flaws in several interventions from the 1990s, particularly in the roofing and support systems. As a result, the

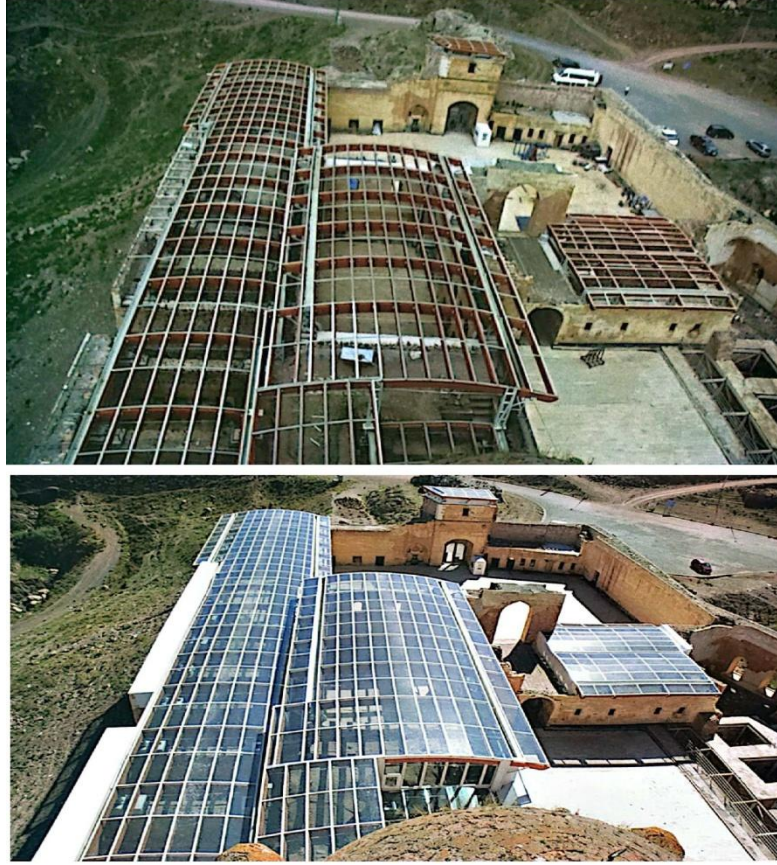
erroneous components were dismantled in 2007, and a new restoration contract was commissioned. By 2010s, the reinforcement of the walls had been completed, and a new 3,000 m² glass-covered wooden roof was installed (Fig.6). Yet, this contemporary design drew criticism for being incompatible with the palace's authentic architectural character, as the use of modern materials was perceived as an intrusive intervention that disrupted the historical fabric (Yıldırım, 2011: 82–84).

Fig.6. Glass-covered wooden roof (Belli, 2012:84)
